Manhole Inspection Summary

Manhole # S31WW_016MH

Insp Date: **10/16/07 10:14 AM**

Location Address: **301 WYMAN PARK DR**

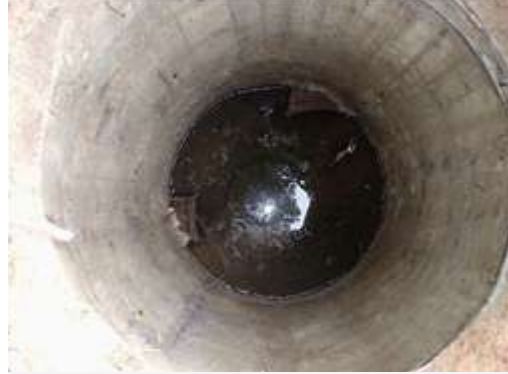
Top View

Corroded and missing steps. Channel debris.

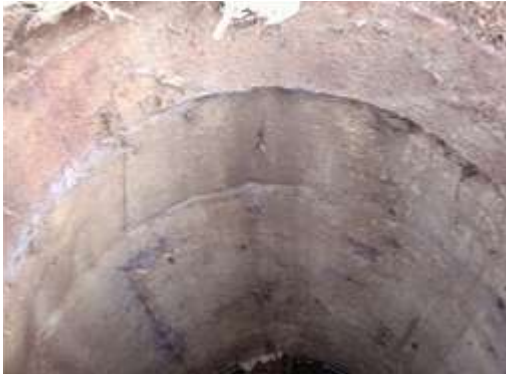
Defect

Frame leaks. Adjustment infiltration - other side.

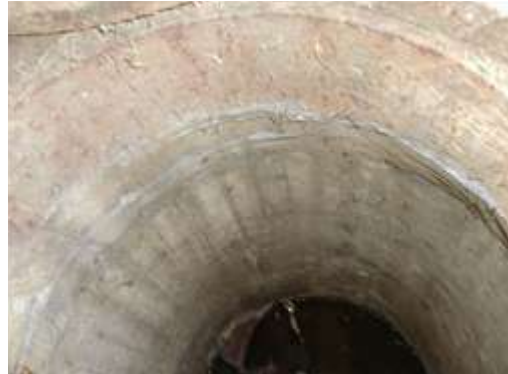
Defect

Frame leaks. Adjustment infiltration.

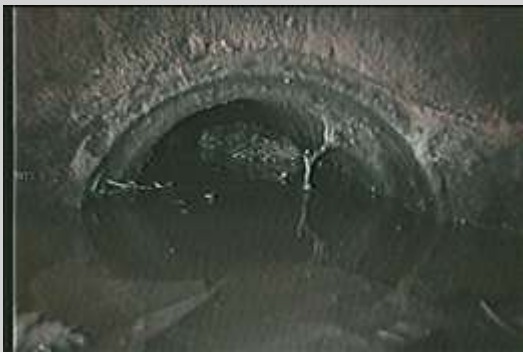
8 in. Circular Gravity Sewer Pipe Out @ 12 O'Clock

Deposits: ☐ None ☒ **Mud** ☐ Sludge ☒ **Debris** ☐ Grease

Silt Depth: **2** (in.) Deposits Extent: **Light**

Infiltration: **Evidence** Pipe Seal Cond: **Unknown**

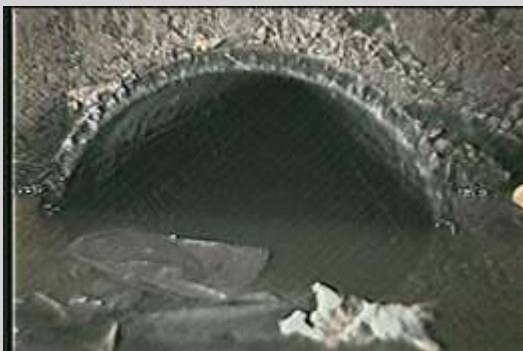
8 in. Circular Gravity Sewer Pipe In @ 9 O'Clock

Infiltration: **Evidence** Pipe Seal Cond: **Cracked**
